Illinois Commerce Commission  
Assessment of Union Electric Company's  
Reliability Report and Reliability Performance  
for Calendar Year 2004

Pursuant to 83 Ill. Adm. Code 411.140

January 2005

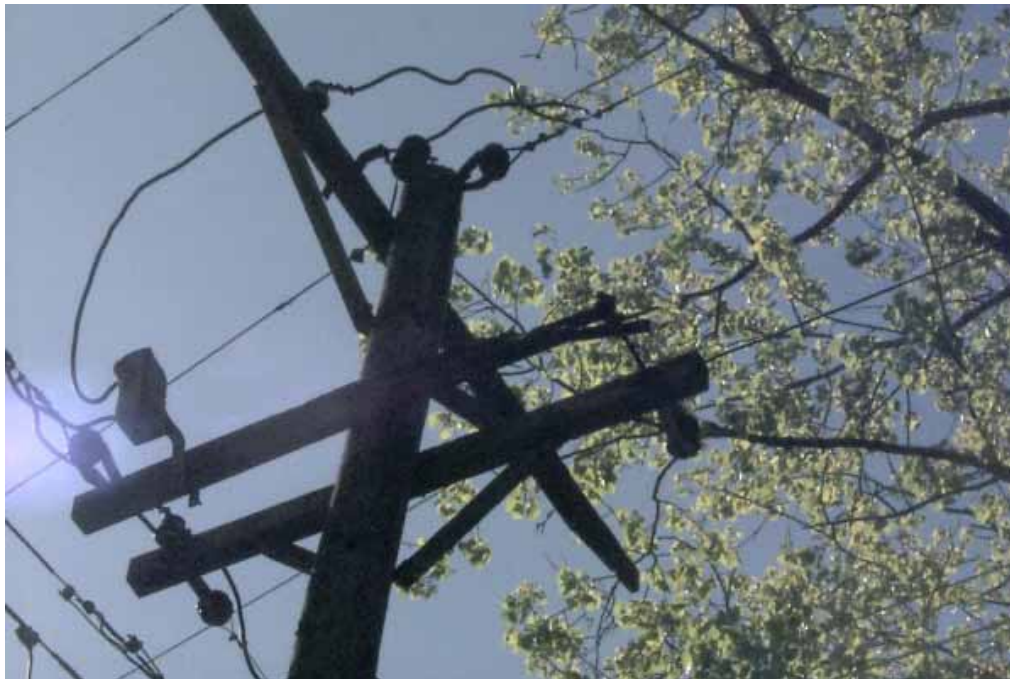
VanBuren and 44th Street

Of the seventeen outages on this circuit in 2004, four were total circuit outages. Eight of the outages AmerenUE reported were caused by weather, six were due to overhead equipment problems, and two were due to trees. AmerenUE reported that their general circuit-wide trim of this circuit was completed in May 2003 and mid-cycle trimming was completed in February 2005. Staff inspected this circuit in May, 2005 and found only two locations where vegetation was contacting the primary, and was generally pleased with the tree clearances along this circuit and the condition of the distribution facilities. The only threat to reliable service that Staff noted was due to the apparent age of the facilities, photos number 1 and 2 show examples of the aged hardware found during the inspection. Staff did find many potential problems with older poles and hardware. See Attachment A for a listing of seven locations where pole or hardware concerns were observed.

**Photo 1: Two split crossarms**

Ameren should consider starting a program to replace the old facilities and bad poles on this circuit in an attempt to improve its overall reliability.

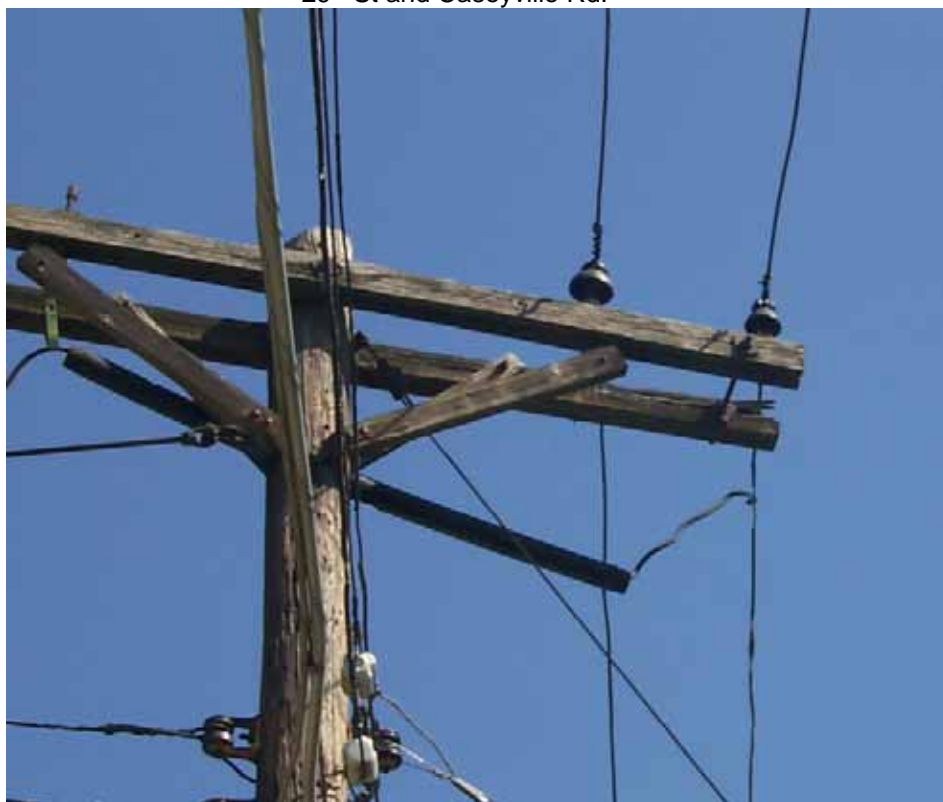
29<sup>th</sup> St and Caseyville Rd.

**Photo 2: crossarms weathered and brace off**

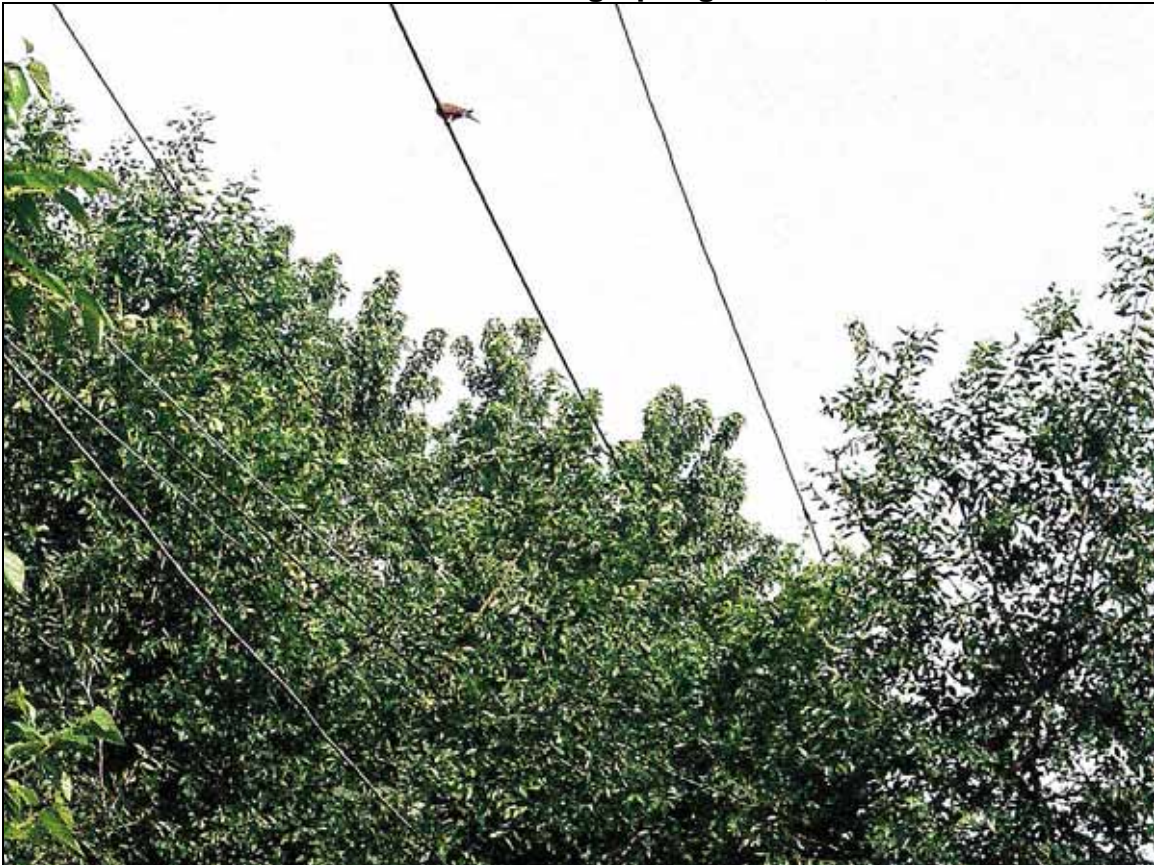
I observed many tree conflicts with AmerenUE’s lines in Cahokia, including at least three locations where the trees had been burned by AmerenUE’s primary conductors. The problems were not isolated to certain sections, but were scattered throughout the town along the route I drove during the inspection. Figures 1 through 4 show examples of some of the tree conflicts observed in Cahokia.

**Figure 1 (Photo 0501)**  
**Siberian elm tree into 4 kV primary (with burning)**  
**Judith Lane west of Falling Springs Road, Cahokia**

- AmerenUE should investigate the problem areas discussed in this memorandum to determine the cause of inconsistency of tree trimming in these areas with the rest of its tree trimming program in Illinois.
- AmerenUE should resolve all existing tree clearance problems in its Illinois service territory as soon as possible.
- AmerenUE should assure that it meets the requirements of NESC Rule 218 by assuring that all trees in its Illinois service territory are trimmed such that there are no tree contacts with its energized primary conductors before it returns to trim them again.

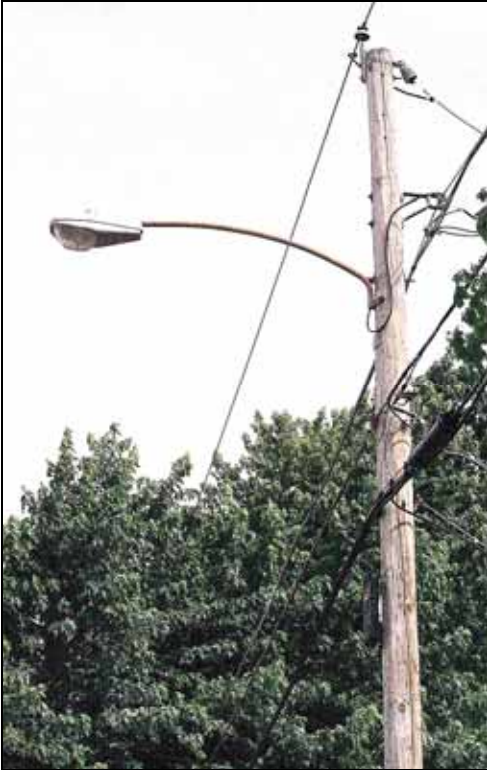
**Figure 2 (Photo 0507)**  
**Chinese elm tree into primary**  
**Nelson Ave. NE of Leon St., Cahokia**

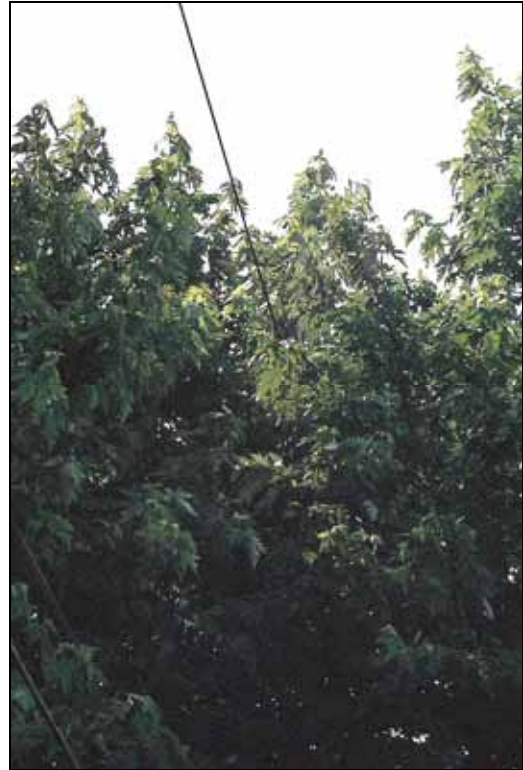
**Figure 3 (Photo 0508)**  
**Primary through soft maple tree**  
**Jerome Ln. SE of Genevieve Pl., Cahokia**

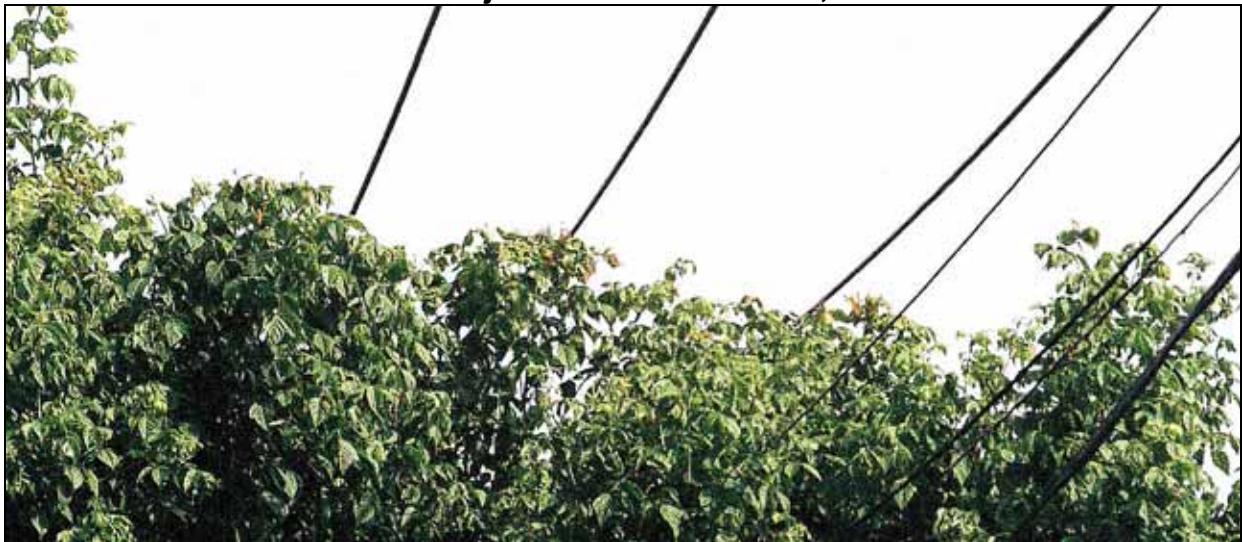
**Figure 4 (Photo 0504)**  
**Box elder tree into 3-phase primary**  
**Elizabeth St. just SW of Jerome Ln., Cahokia**

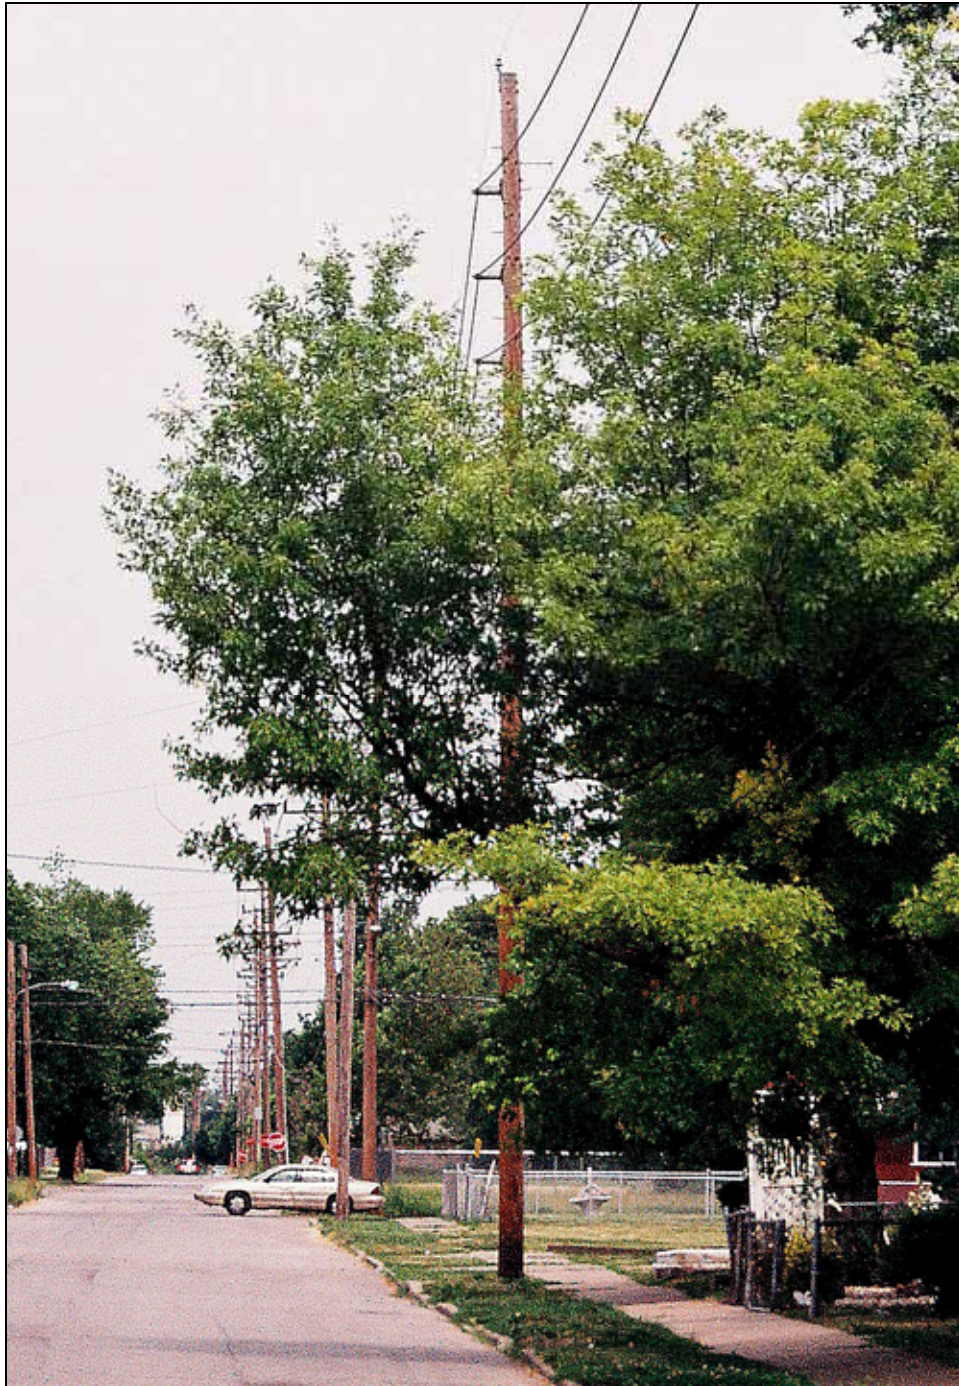
Tree trimming all along the route inspected in East St. Louis looked very well done, except for one location where a pin oak tree had grown into an AmerenUE 34 kV line. This location is shown in Figure 5. I did see fresh cuts on some of the trees in East St. Louis.

**Figure 5 (Photo 05O13)**  
**Pin oak tree growing into a 34 kV line**  
**Ohio Ave. between 29<sup>th</sup> & 31<sup>st</sup> Sts., East St. Louis**

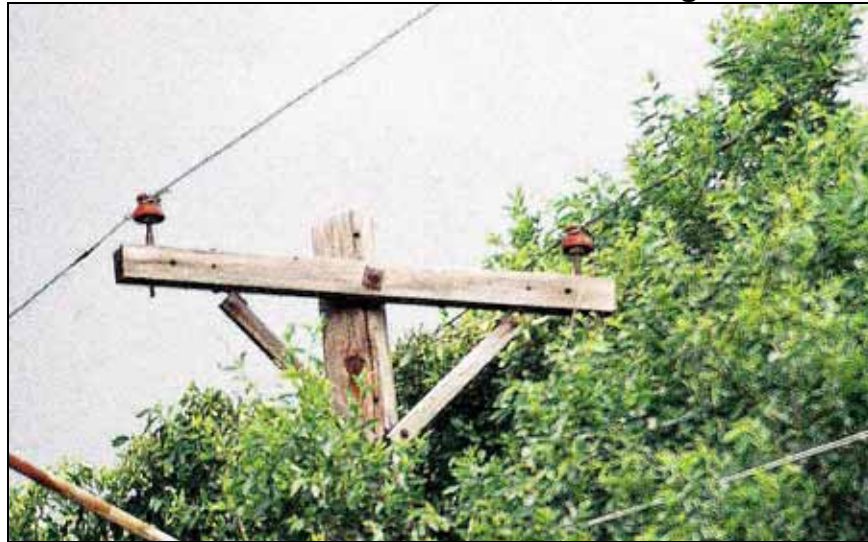
Tree trimming along the route inspected in Washington Park was also very well done, with only two problem locations noted. One of those locations is shown in Figure 6.

**Figure 6 (Photo 05O14)**  
**Chinese elm tree into 3-phase primary**  
**Hill Ave. between 60<sup>th</sup> & 61<sup>st</sup> Sts., Washington Park**

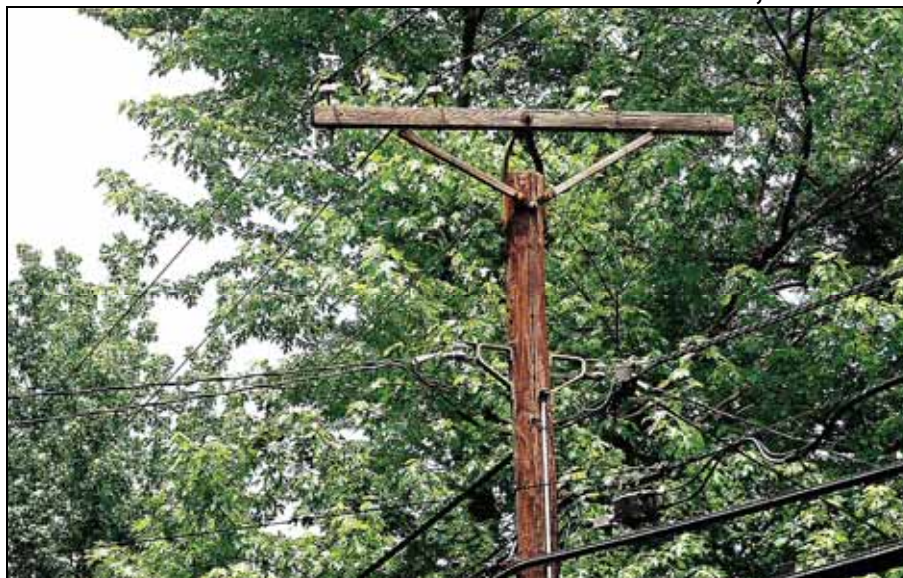
I found many tree trimming problems in Alton, scattered throughout the route I chose to inspect. Most of these conflicts involved fast growing tree species. AmerenUE clearly has not trimmed trees in Alton to adequately allow for the amount of tree growth that has occurred before it trims the trees again. Some of the conflicts noted are shown in Figures 7 through 9.

**Figure 7 (Photo 05O20)**  
**Primary through edge of soft maple tree**  
**Main St. between Grandview & Sanford Aves., Alton**

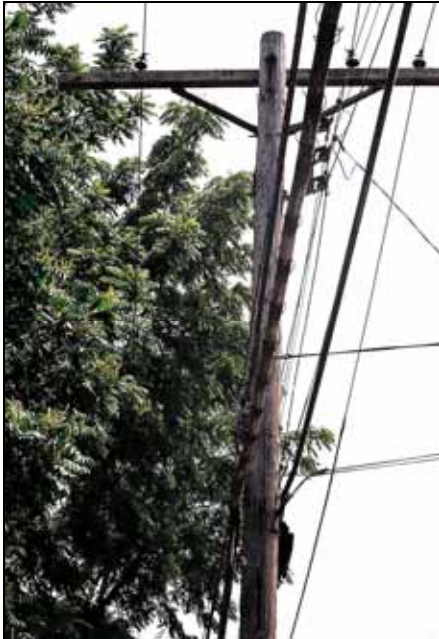
**Figure 8 (Photo 05O21)**  
**Chinese elm tree into primary**  
**Main St. south of Benbow, Alton**

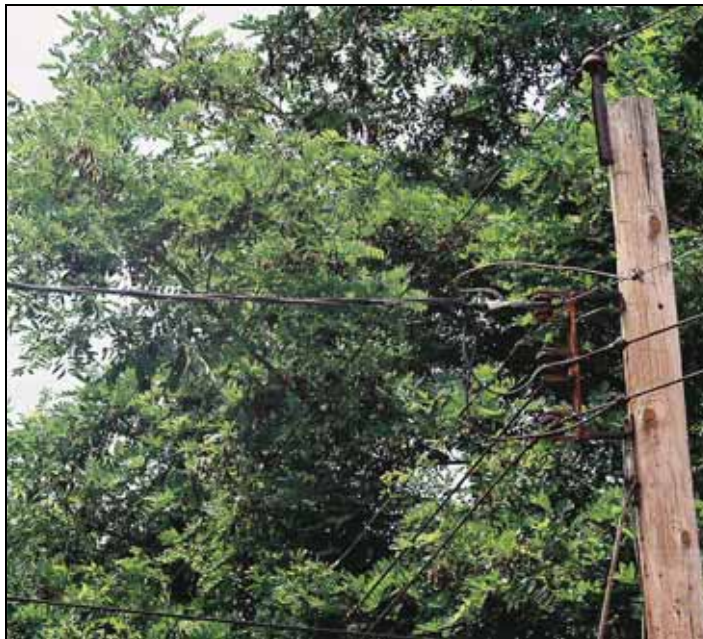
**Figure 9 (Photo 05O19)**  
**Primary through several locust trees**  
**Ida St. west of Main St., Alton**
